# Summary of inspections and investigations on post-tensioning components of Herøysund Bridge, Norway (2017-2023)

Trondheim – January – 2024

WP2.A2

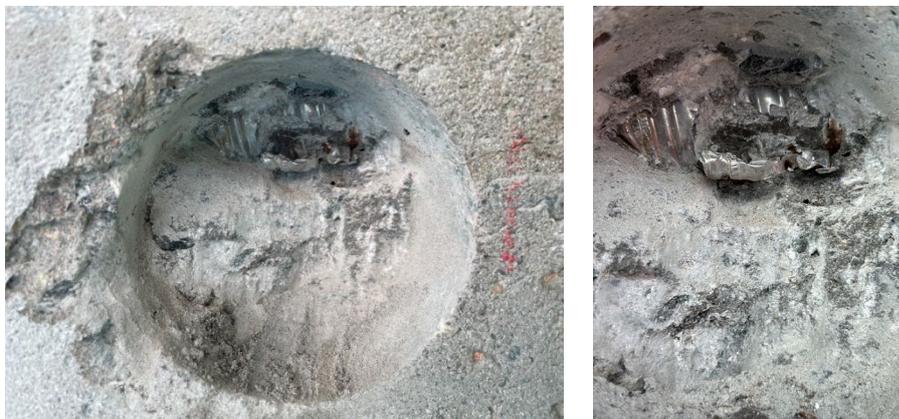
Filled up with filler material. Only surface corrosion was observed on wires and duct (inside), see Figure A-1.

Figure A-1: Fully grouted Hole 1SA.

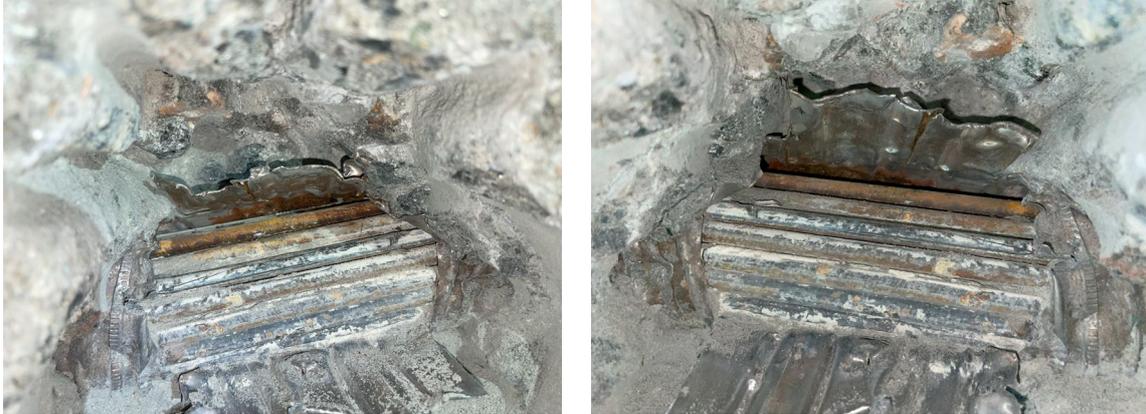
Two wires could be moved which indicated that they were broken. The use of an endoscope indicated that more severe corrosion occurred away from the drilled hole. To examine this further, a new hole was drilled 300 mm away (south) of this hole (2SA-2, see Figure A-2).

Figure A-2: Surface corrosion on wires on the top of the duct (Hole 2SA-1).

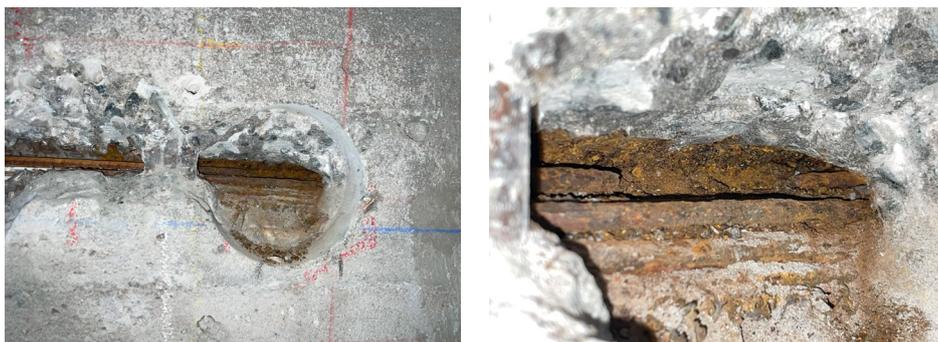
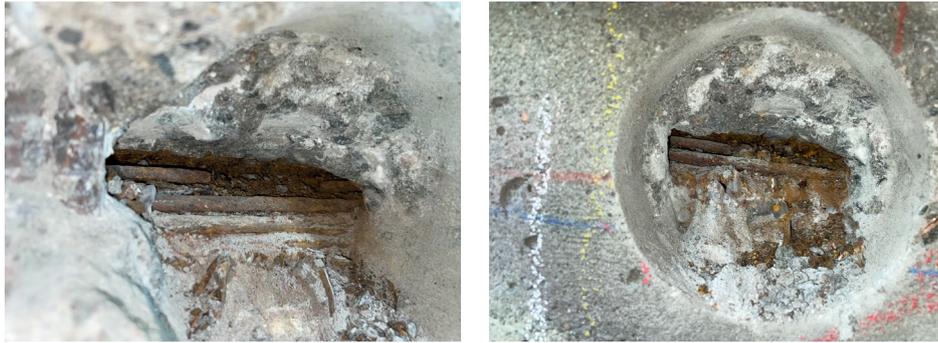
From the study conducted by [2], the fractured wire collected from test location 2SA-2 of the bridge was severely corroded and had 35% reduction in diameter. Moreover, EDS analysis concluded that chloride and sulfur were not present in the corrosion products. The detailed investigations and results carried out on tension wires are provided in detail in [2].

Corroded duct on the inside.

*Figure A-3: Extensively corroded and fractured wire on top of the duct (Hole 2SA-2).*

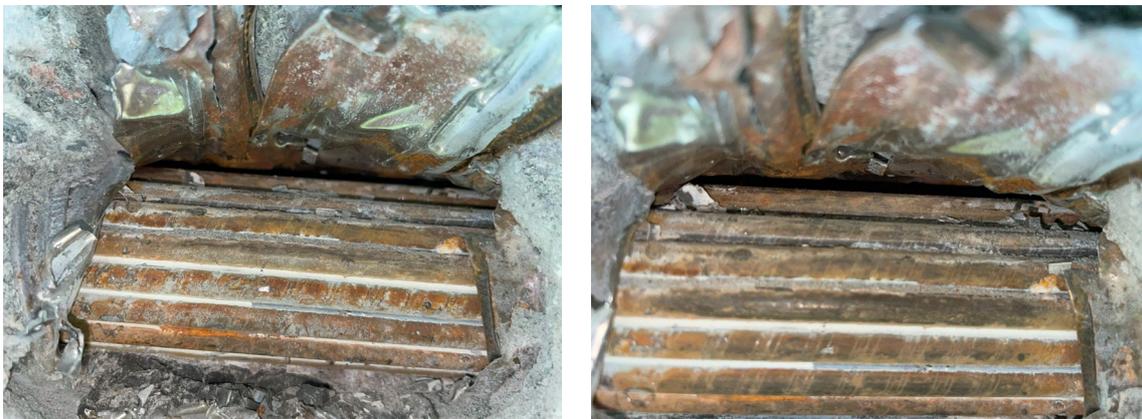
The internal part of the duct was slightly corroded.

*Figure A-4: Corroded wires along with internal corrosion in the duct (Hole 2SA-3).*

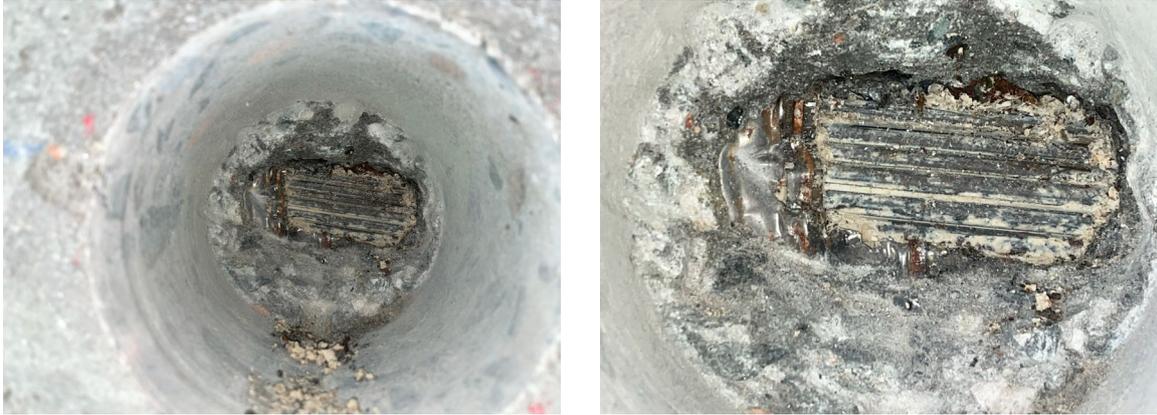
Slight corrosion of the ducts on the inside.

*Figure A-5: Wet filler material (Hole 2SA-4).*

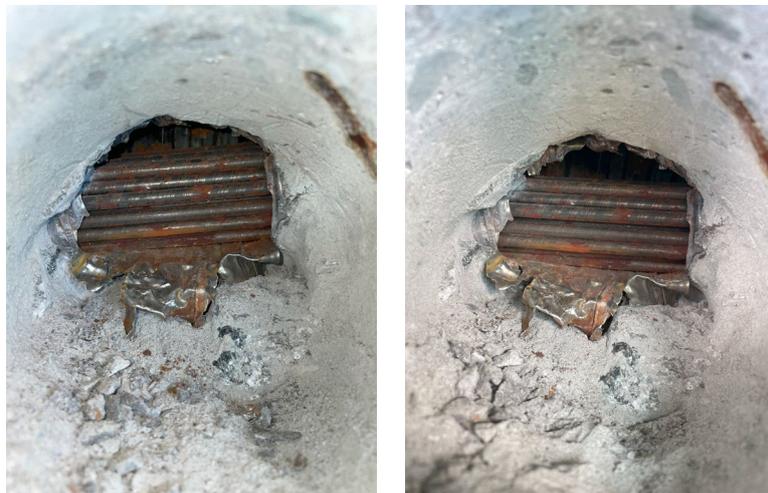
Corrosion was observed on the internal surface of the duct.

*Figure A-6: Presence of void along with corrosion of tension wires and duct (Hole 3SA-1).*

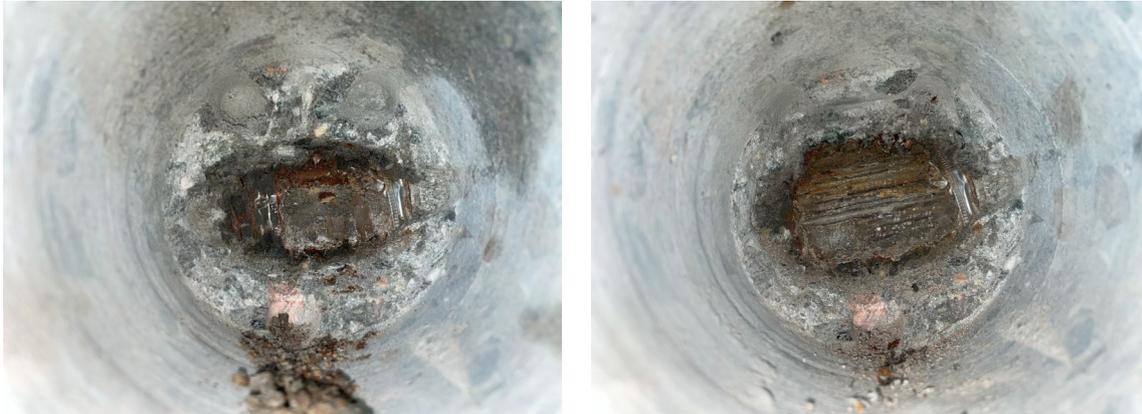
The duct was corroded both on the inside and outside.

*Figure A-7: Fully injected duct with corroded tension wires (Hole 3SA-2).*

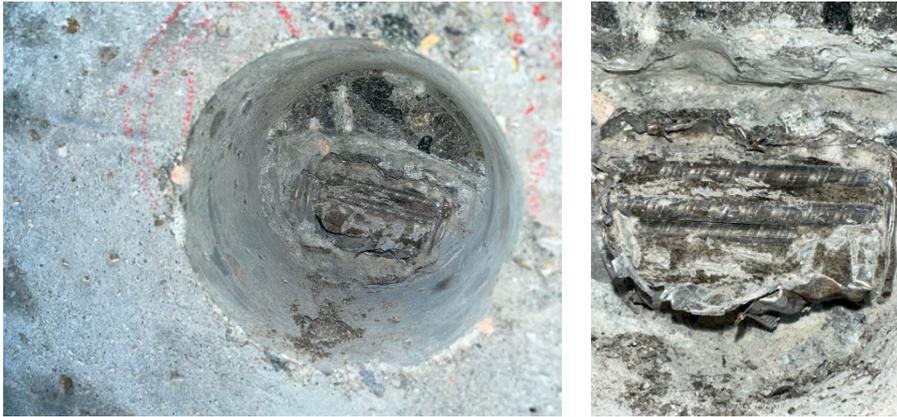
Fully grouted with filler material.

No corrosion was observed – both on the duct and on the wires, see Figure A-8.

Figure A-8: Fully injected duct with no corrosion (Hole 1NA).

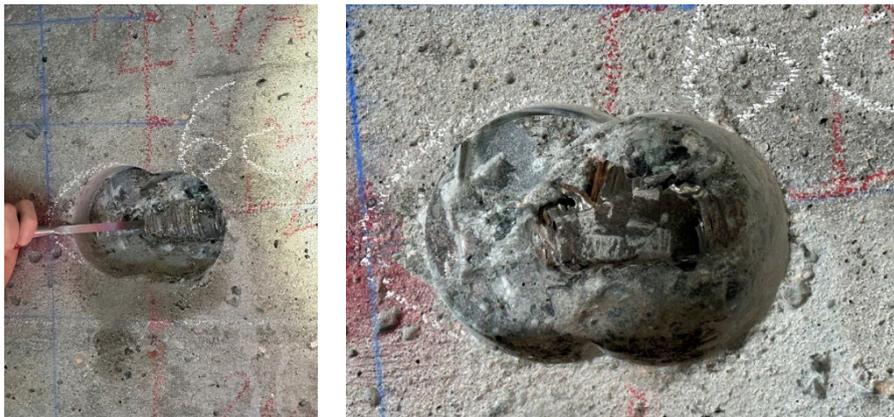
No corrosion was observed – both on the duct and on the wires.

Figure A-9: Filled with filler material and corrosion of duct only on the overlapping area (Hole 2NA).

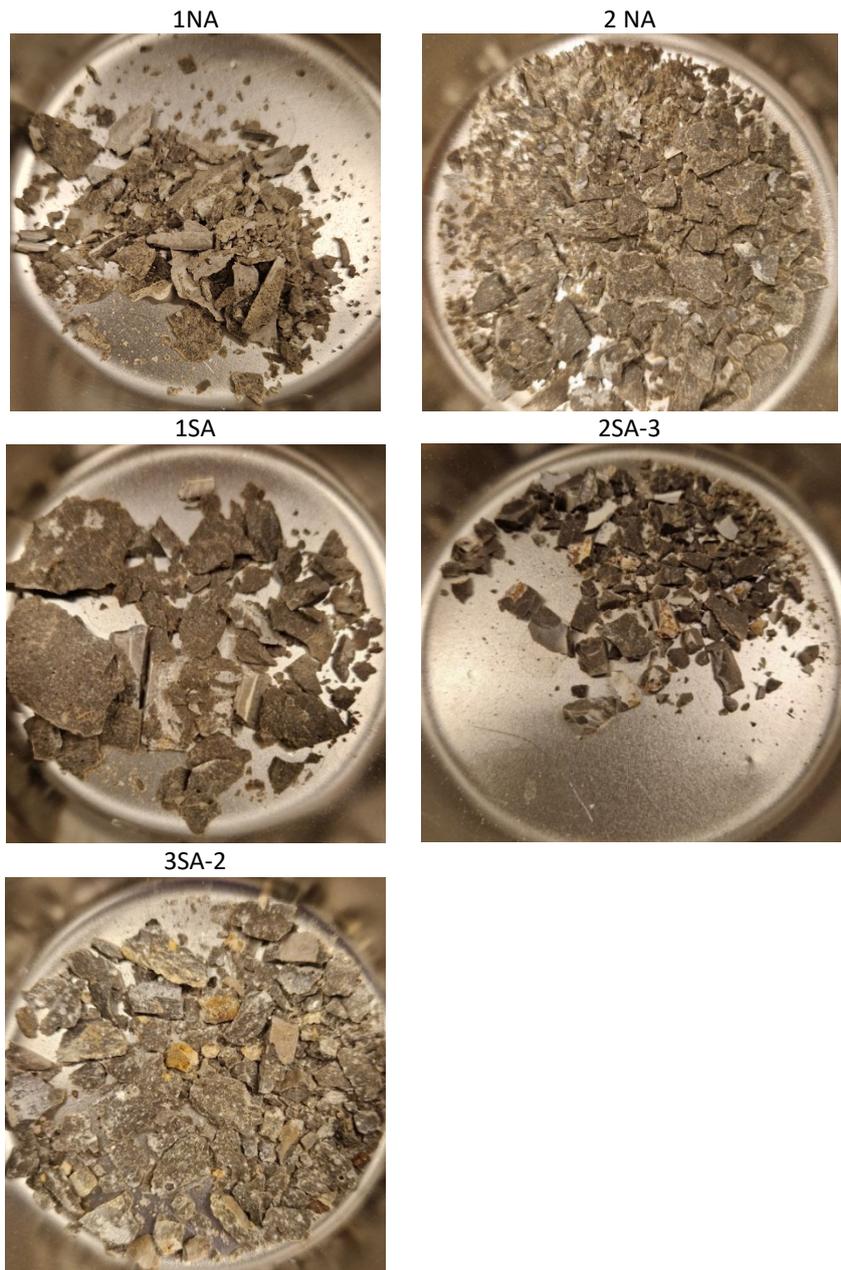
Group 1 samples appeared to be dry and resembled hardened cement paste with a dark grey colour. Some samples had brown/red-brown spots (2SA-3 and 3SA-2) on the surface of some particles, indicating potential contact with rust. Surface corrosion of tension wires was observed at the location of samples 1SA, 2SA-3, and 2SA-1.

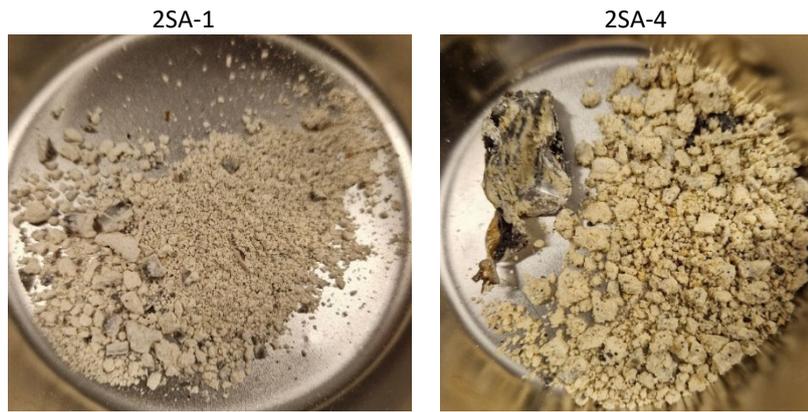
Group 2 samples had a lighter colour compared to Group 1 materials, and notably, sample 2SA-4 appeared very moist. Sample 2SA-4 contained a larger piece of metallic material, which was removed before further analysis. The samples also seemed to have lower strength, meaning less resistance to crushing. Group 2 resembled samples received earlier in 2020 [4, 5].

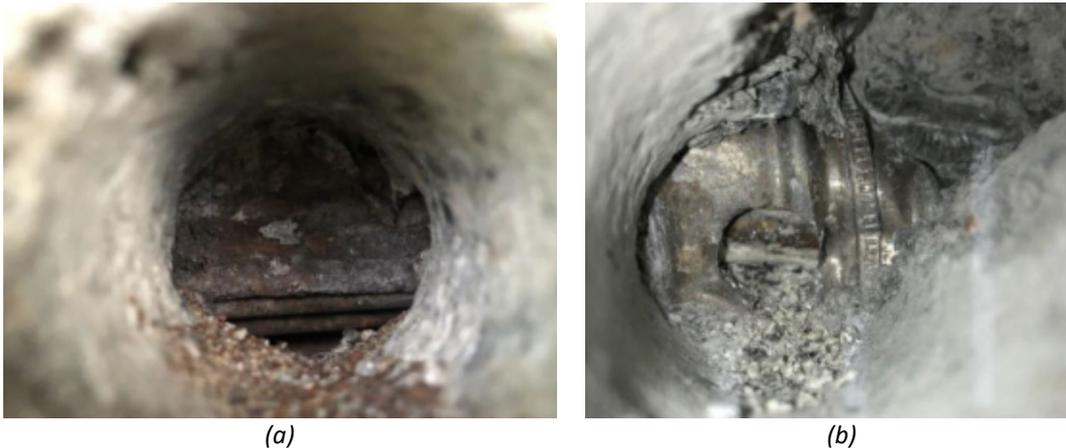
Figure B-1: Images by Ultrasonic and Impact Echo (a) Voided duct (1NC) (b) Grouted duct (1SC) [6].

Figure B-1 depicts two examples of visual inspection of ducts and tensioning wires in areas where findings were detected using Ultrasonic and Impact Echo. Figure B-1 (a) was assessed to contain voids (inside the duct), while Figure B-1 (b) was determined to be without voids. This aligns well with what was documented during the visual inspection after the concrete was removed. The visual inspection also documented that both the duct and tensioning wire were subject to corrosion in the area with voids (missing filler material), whereas there were no signs of corrosion (visible brown rust) in fully grouted ducts.

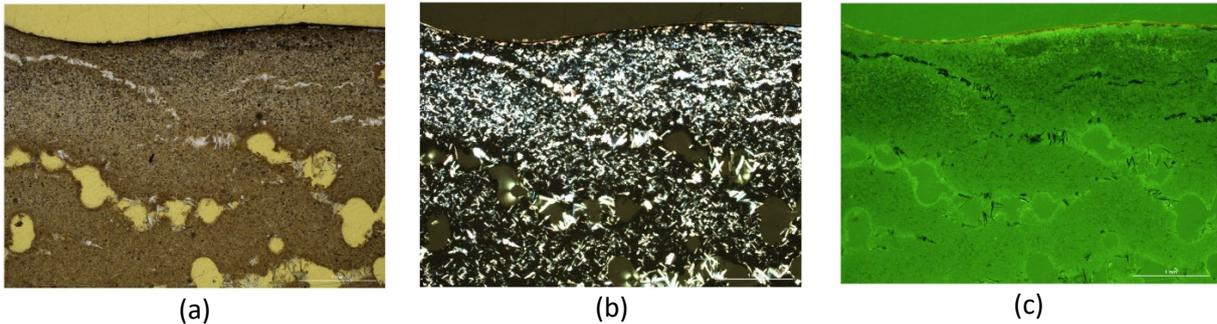
*Figure C- 1: Presumed contact with the duct is at the top part of the image. The filler material appears to be slightly more 'coarse-grained' closer to the duct than further away. (a) Section from thin section (b) Section in polarized light showcasing portlandite by sparkling crystals (c) Section in fluorescent light showcasing rust product on the top and distinction in porosity and grain size approx. in the middle of the image [5].*

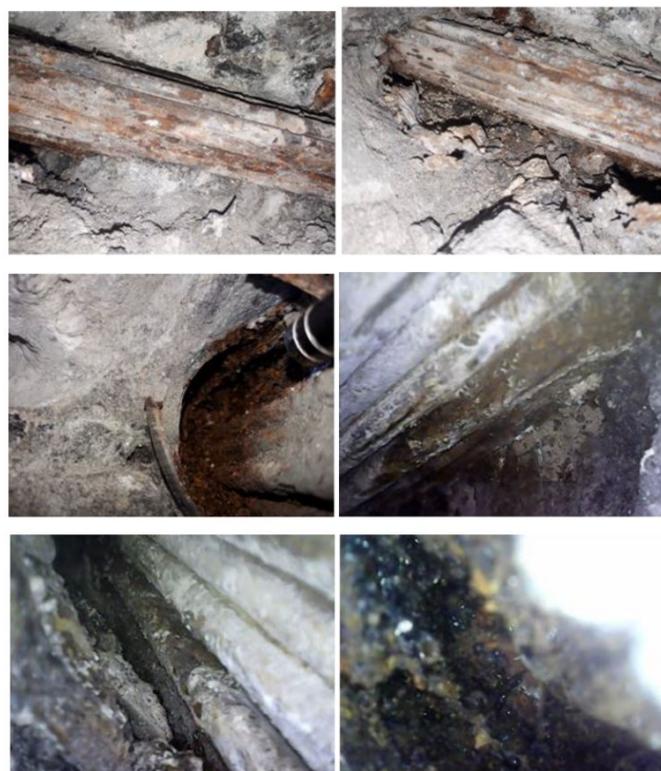
The wires in this location were found to be uniformly corroded in general and the formation of brown rust was observed as shown in the image (1-15) of Figure D-2.

Figure D-2: Photos focusing corrosion (Test location 1) (Image 1-15, 1-16, 1-17, 1-10, 1-9 and 1-12)\* [1].

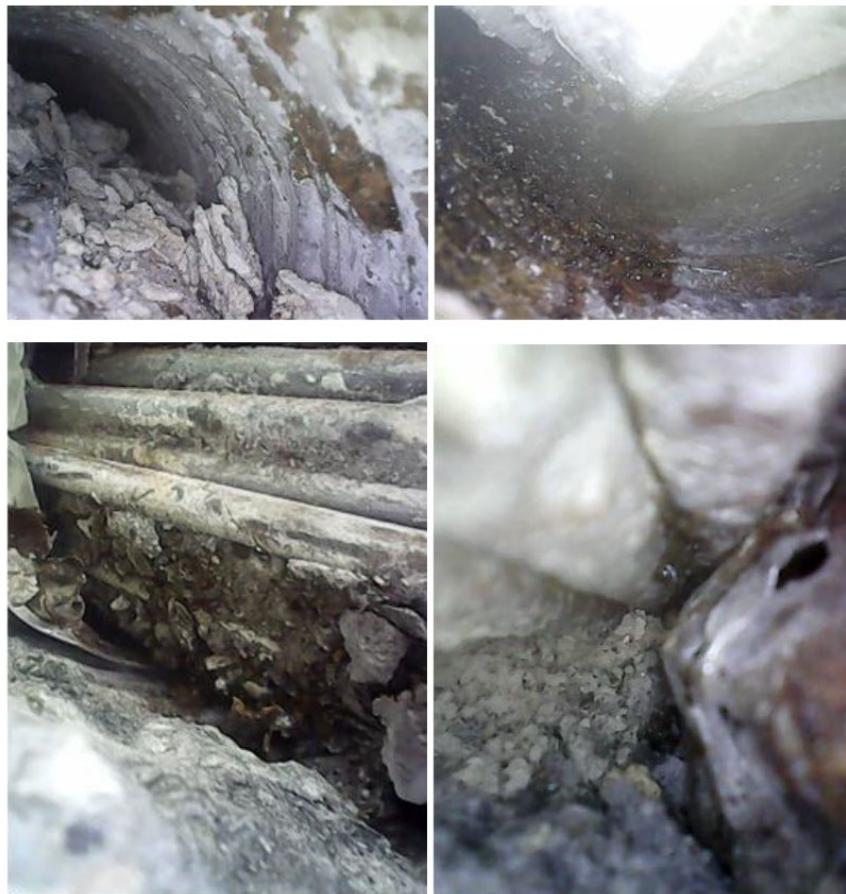
While assessing the condition of the ducts, images (1-6, 1-7, and 1-8 (Vedlegg 5)) illustrate that filler material adheres internally in the duct around the entire circumference and the condition of the duct is not visible. However, brown rust around the duct can be observed where voids are present. In the image (1-5) (Vedlegg 5), the duct is also visible, but here the internal surface is shiny. The external surface of the duct is shown in image (1-15), and it also appears to be shiny.

Figure D-3: Photos focusing filler material (Test location 1) (Image 1-6, 1-7, 1-11, and 1-3)\* [1].

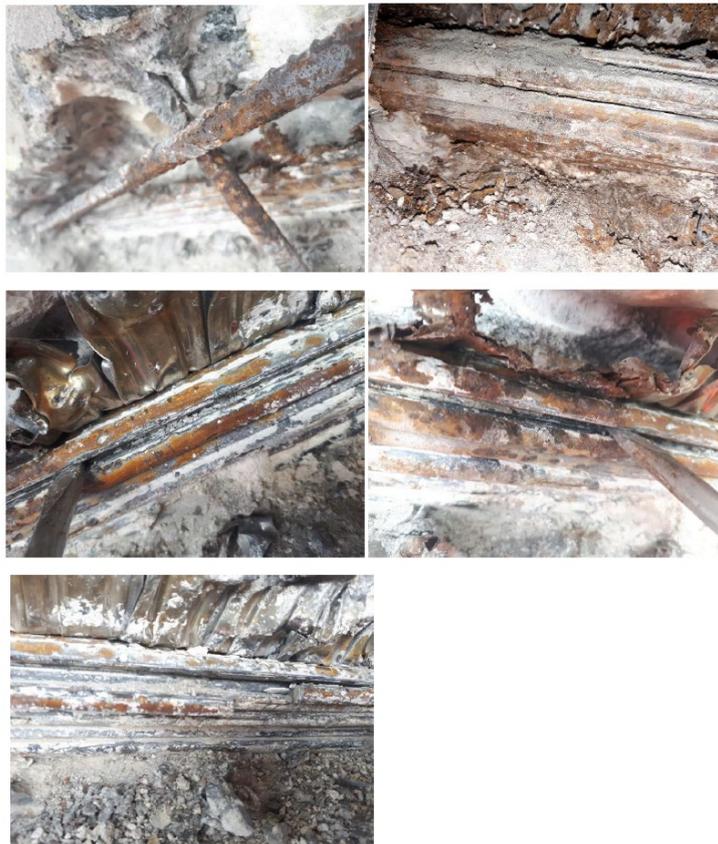
After the concrete was removed from the test location, it was observed (Figure D-6: Image (2-2)) that some part of the duct was slightly compressed, indicating the presence of voids in the area. Then the duct was torn up to observe the condition of the tension wires. For Test location 2, it can be seen that some parts of the wires were covered with corrosion products (2-4) (Vedlegg 5), while the remaining parts were covered with adherent filler material (2-7) (Vedlegg 5). In the upper part of the duct, the tension wire was subjected to significant corrosion (2-4, 2-16).

Figure D-5: Photos focusing corrosion ( Test location 2) (Image 2-14, 2-10, 2-15, 2-16 and 2-18)\* [1].

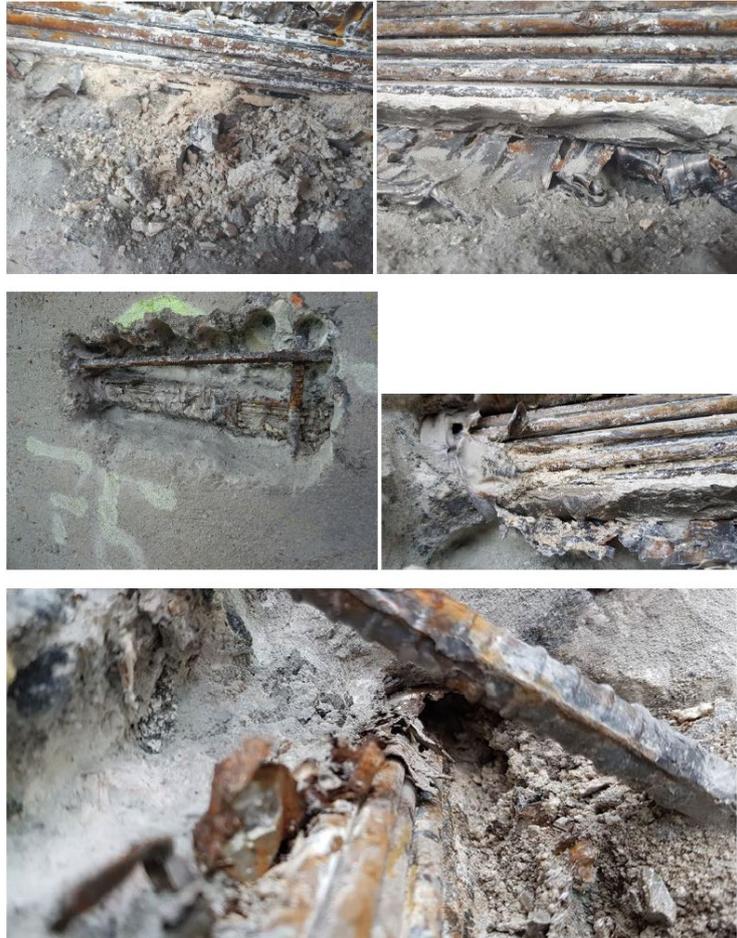
One of the tension wires was cut for examination in the laboratory. After it was cut at one end, it retracted about 20 mm (2-8). Then, a length of 350 mm of the tension wire was cut to conduct further analysis at NTNU (2-19) (Vedlegg 5). Loose tension wires (2-15, 2-16) that could be moved with a screwdriver were also discovered in this area.

Figure D-6: Photos focusing filler material (Test location 2) (Image 2-11, 2-12, 2-2, 2-5 and 2-6)\* [1].

From the inspection of filler material, it was found that some parts were filled with filler material, but some parts included voids (2-2). The wires covered with filler material showcased full protection from corrosion whereas parts exposed to voids were susceptible to corrosion (2-5). Figure D-7 shows filler material from two areas in Test location 2.

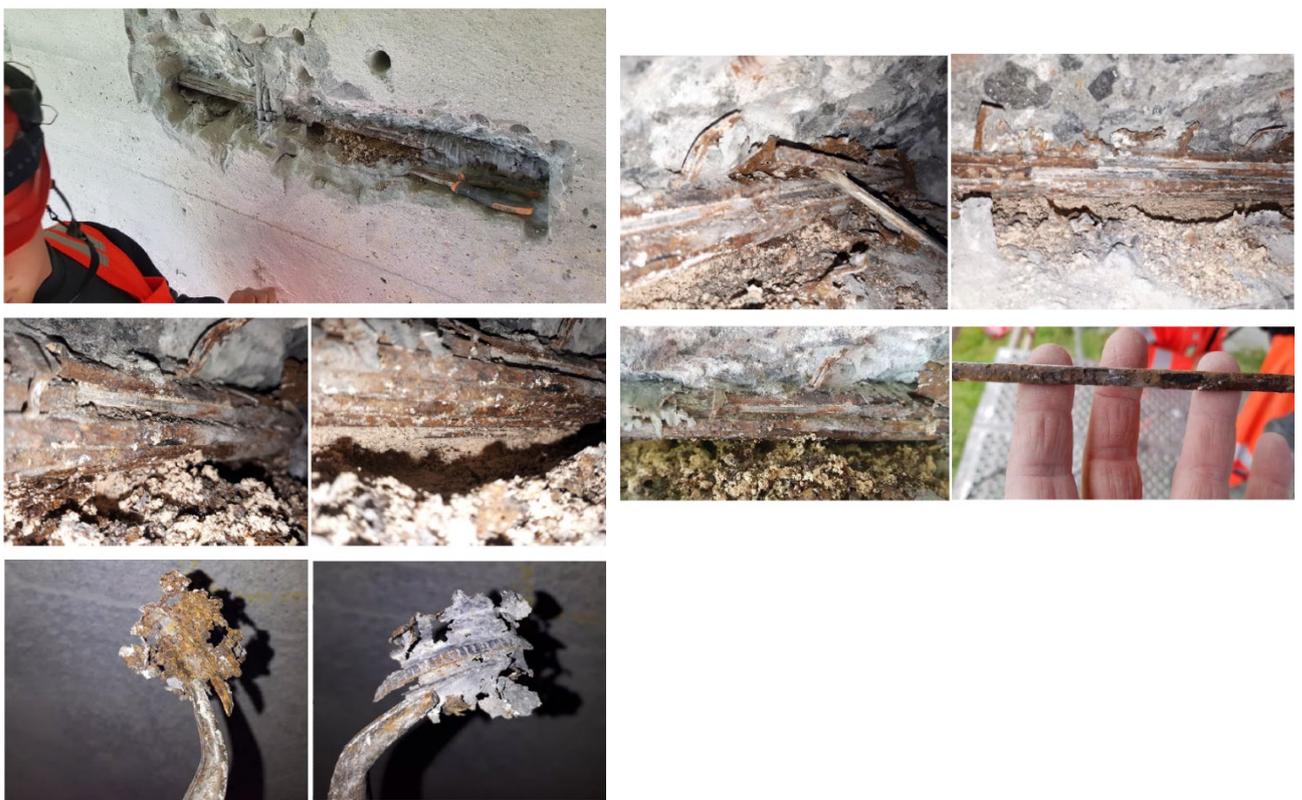
This test location was given priority, and a closer examination was conducted because severe corrosion attacks on the tension wire were observed during the inspection in October 2019. These findings were also documented during this inspection. Additionally, a tension wire that had fractured (Figure D-8: Images (3-2, 3-8 (Vedlegg 5), 3-22, 3-23 (Vedlegg 5)) was discovered. The fracture occurred in wire number 2 from the top as shown in Figure D-9. It can be observed in the image that the fracture in the wire resulted in a gap of 80-90 mm between the fracture surfaces. Pieces of the broken wire were cut - both ends - along with a piece of the nearest tension wire for analysis. Characterization of corrosion attacks, the composition of corrosion products, and analysis of fracture surfaces/areas were analyzed and are presented in Section D.3.1. Moreover, surface corrosion is evident on the wires, as depicted in Figure D-9. It was observed that more corrosion occurred on the wires located at the bottom of the duct. However, it is important to note that the wire with fracture was located at the top of the duct and not at the bottom.

Figure D-8: Photos focusing corrosion (Test location 3) (Image 3-3, 3-16, 3-19, 3-20, 3-21, 3-22, 3-25, 3-2, 3-9)\* [1].

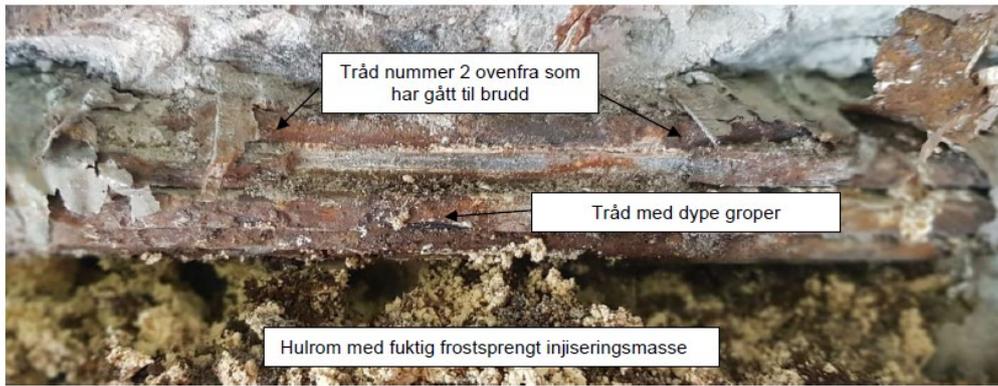
Figure D-9: Tension wire with fractures and other tension wires with deep corrosion pits [1].

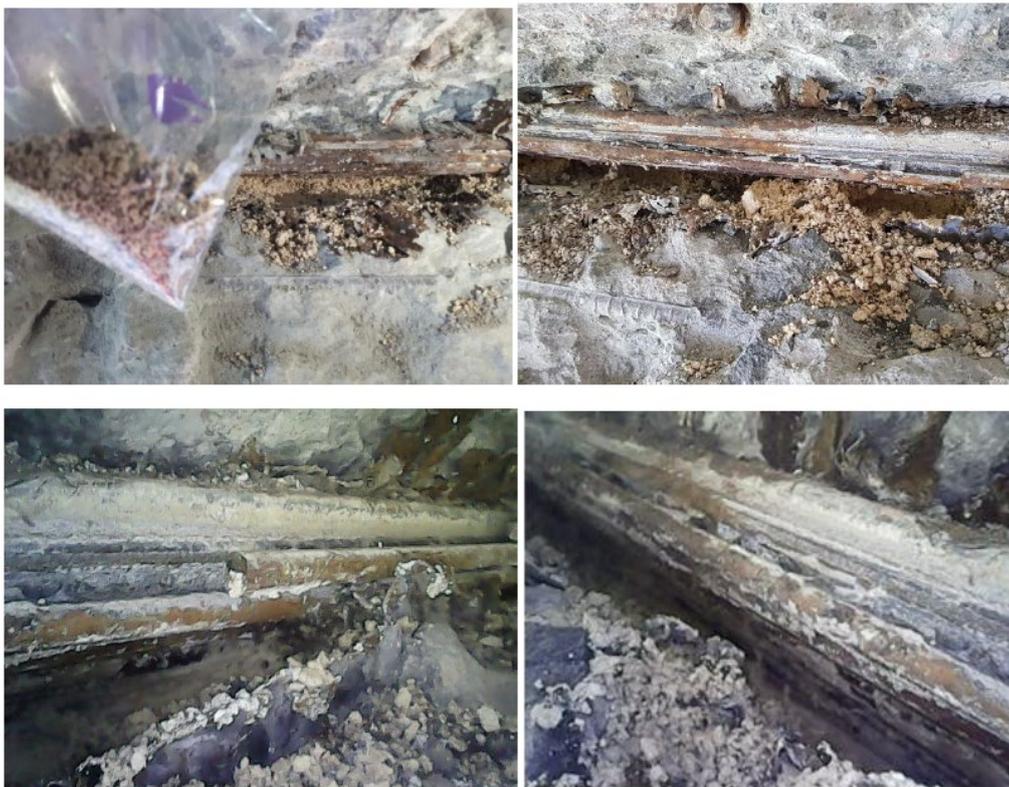
Samples of filler material located 20 cm to the east of this location were collected during the inspection in October 2019 and sent to SINTEF for analysis. The consistency of the filler material in this area exhibited noticeable variations, ranging from dry to moist, and from consistent to frost-damaged. Moist and frost-damaged filler mortar was found in the area where a tension wire had fractured, as depicted in Figure D-9. Samples of moist filler material from this area were taken for further analysis at SINTEF. The inspection also documented voids in some parts of the duct (3-6, 3-7) (Vedlegg 5). Some parts of the location contained voids (3-8) (Vedlegg 5), while some parts were fully injected with filler material (3-12). This suggests varying effectiveness/quality of filler material inside the duct.

Figure D-10: Photos focusing filler material (Test location 3) (Image 3-18, 3-2, 3-10, 3-12 and 3-13)\* [1].

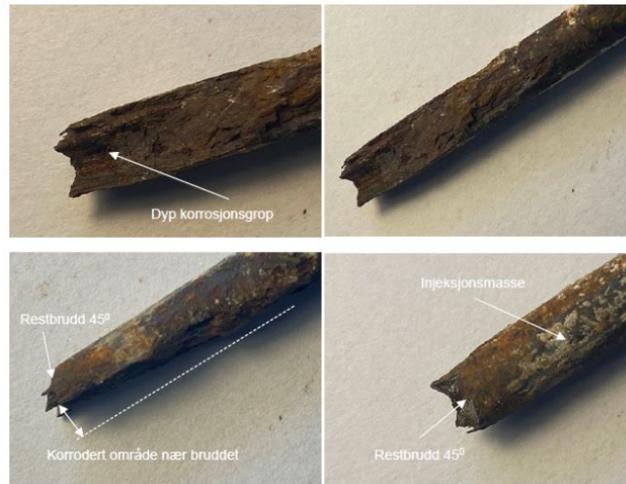
- Corrosion damage on portions of the wire on both sides of the fracture.
- Groove-like corrosion attacks were observed in a length of approximately 20 mm on sections of the cross-section, with minimum remaining cross-sectional area (equivalent to 2.9 mm in height).
- Smaller attacks farther away from fracture, with remaining heights in the range of 4.7-5.5 mm.
- Only a part of the circumference was affected by corrosion, while one of the pieces had a significant area that was adhered with the filler material and was not corroded.
- Residual fracture at 45°.
- The remaining cross-sectional area after fracture was estimated to be approximately 30-35% of the original cross-section.

Figure D- 11: Fractured area on the tension wire depicting severe corrosion damage in the vicinity of the fracture area [1].

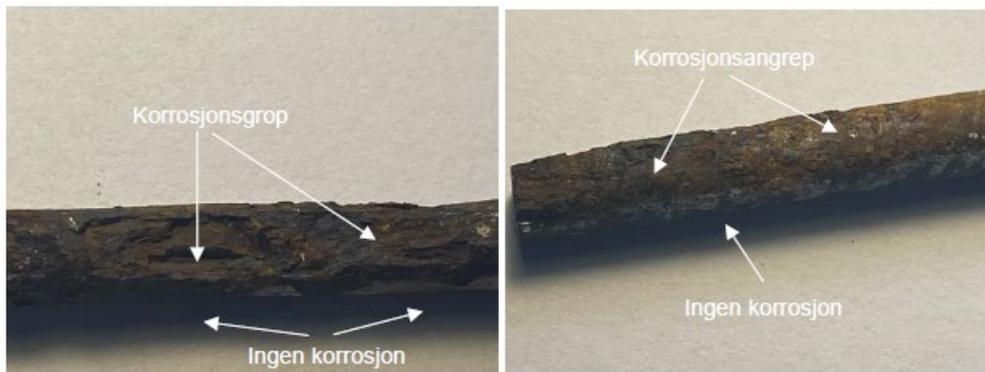
Figure D-12: Photo of corrosion damage on two wire segments. One showcases typical elliptical pits, and other more 'uniform' corrosion on a portion of the circumference [1].

- On one of the 90 mm long segments, there were deep corrosion pits over a length of 50 mm. The pits had an elliptical shape with a length of 5-15 mm, a depth of up to 1.5 mm, and a width of 3-4 mm. All the pits were on the same part of the circumference, while the rest of the circumference showed no signs of corrosion.
- On another 70 mm long segment, uneven and uniform corrosion was observed on one-half of the circumference, with a diameter in the range of 5.9 – 6.1 mm along the entire length of the sample. While no corrosion was observed on the remaining part of the circumference.
