**HERØY F&U**

**WP2.A4 “Corrosion mechanism including effect of environmental parameters”**

**Summary of work and findings**

**Nordland Fylkeskommune and Statens Vegvesen**

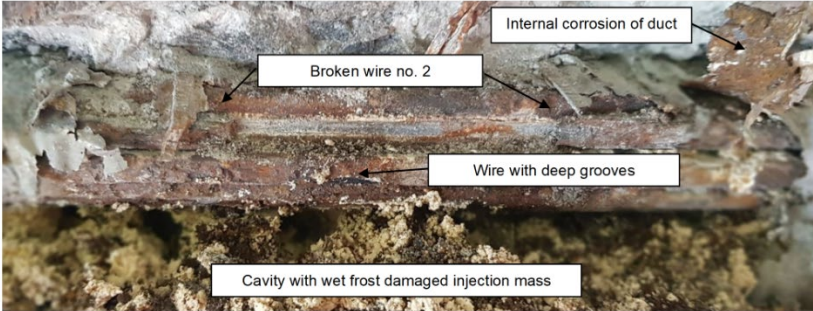
Internal corrosion of duct

Broken wire no. 2

Wire with deep grooves

Cavity with wet frost damaged injection mass

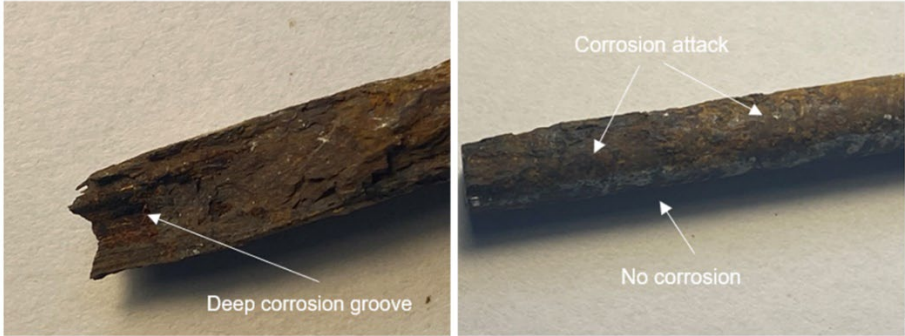
## FRACTURE IN WIRE

Deep corrosion groove

Corrosion attack

No corrosion

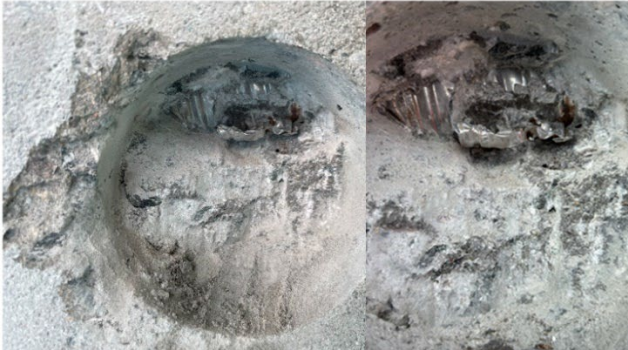
**1SA** moisture = 10.2%, injection mass: 13.7%

**Corrosion observations**

- o Filled up with injection mass
- o Only **surface corrosion** seen on wires and inside duct

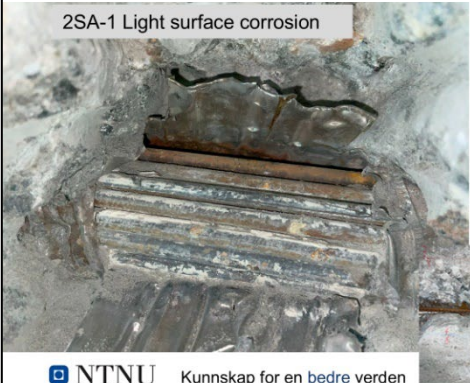
2SA-1 Light surface corrosion

**Corrosion observations 2SA-1**

- o No corrosion on duct outside, but some rust on the inside
- o Brow rust on the top wires (surface)
- o Injection mass covered the gap between the wires.
- o Injection mass was lacking on the top
- o Two wires could be moved

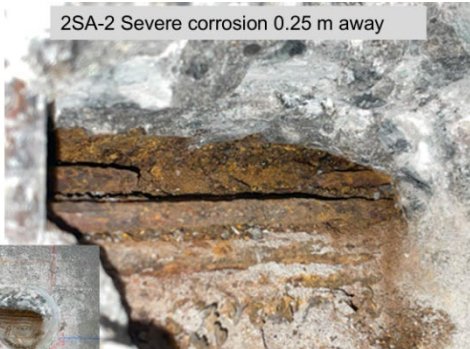
2SA-2 Severe corrosion 0.25 m away

**Corrosion observations 2SA-2**

- o Lack of filler for the upper part (1/3) of the wires
- o Serious corrosion on wires in the part without injection mass
- o **One wire was broken**
- o On another wire, ~40% of the cross section was corroded away in a length ~ 100 mm
- o The internal surface of the duct was corroded

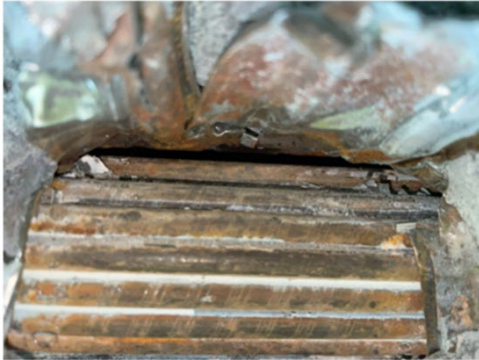
## 2SA-3 $Cl^- = 0.07\%$ , moisture = 10.2%, injection mass: 1

### Corrosion observations

- Injection mass between the wires, but lacking in the top
- Surface rust, but production marks could be seen
- Internal corrosion of the duct on the top, and also further down

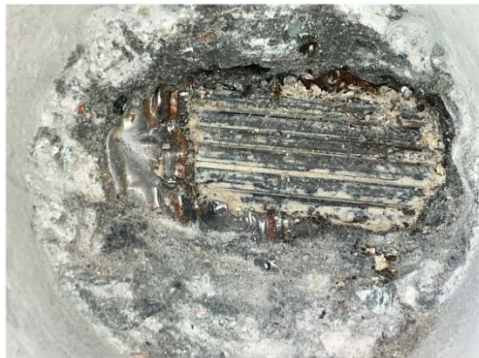
## 2SA-4 $pH = 12.44$ (PW), $Cl^- = 0.039\%$ , moisture = 45.1%, injection mass: 2

### Corrosion observations

- «Wet» injection mass covering the wires and the volume between wires
- Light surface corrosion on wires, but production marks could be seen
- Slight corrosion on the inside of the duct

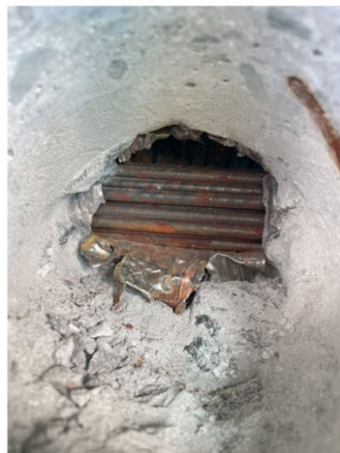
## 3SA-1

### Corrosion observations

- No injection mass
- Some shallow surface corrosion (production marks could be seen)
- Indication of local corrosion attacks on wire(s) in the bottom of the duct
- Internal corrosion of the duct

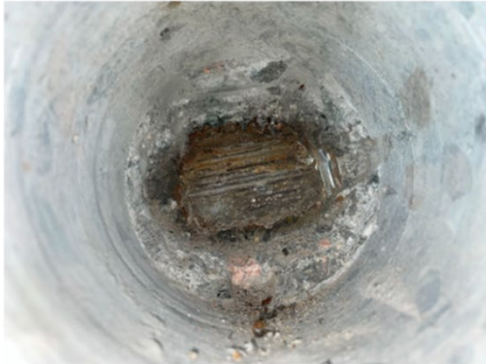
### 3SA-2 $\text{pH} = 13.76$ (PW), moisture = 10.8%, injection mass: 2

#### Corrosion observations

- Bitumen tape covering the outside of the duct (?)
- Shallow corrosion on the duct under the Bitumen tape
- Internal corrosion of the upper part of the duct
- Brown rust on the upper wire, but no/shallow attacks were seen (rust layer due to corrosion of the duct?)

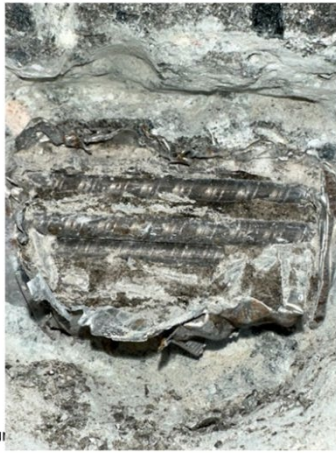
### 1NA moisture = 9.2%, injection mass: 1

#### Corrosion observations

- Completely filled with injection mass
- No corrosion observed (wires and duct)

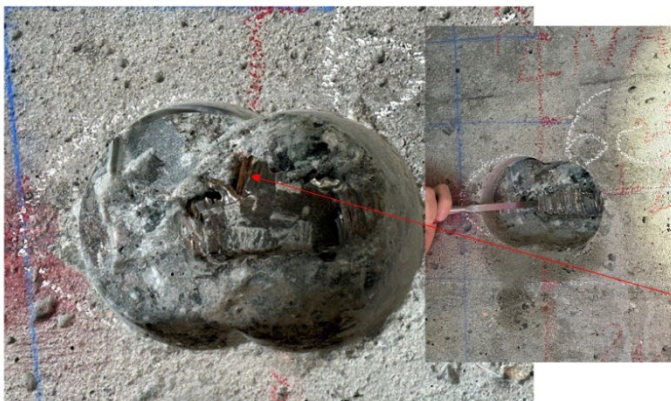
### 2NA $\text{pH} = 14.1$ (PW), $\text{Cl}^- = 0.061\%$ , moisture = 10.2%, injection mass: 1

#### Corrosion observations

- Completely filled with injection mass
- No corrosion observed on wires
- Indication of corrosion on duct
