# Strain-based structural health monitoring of post-tensioned bridge

Herøy FoU: WP1 activities and results report

Trondheim – January – 2025

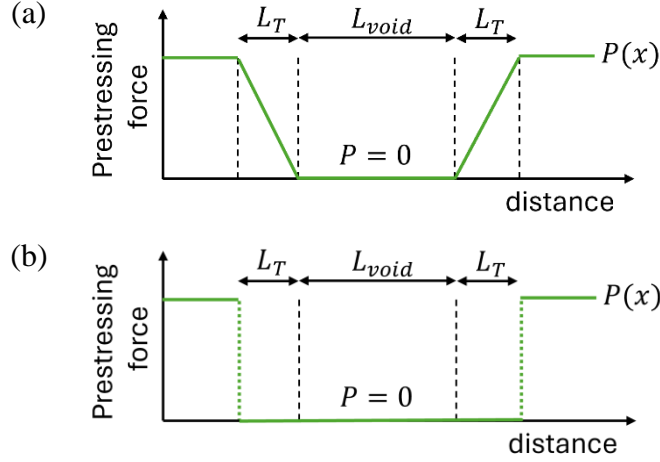
Figure 3: (a) Schematic representation of prestressing force magnitude around the tendon breakage; (b) Simplification of the prestressing force magnitude.

The main effect of tendon breakage is the loss of prestressing force along the affected length. The extent of this loss depends on the length of the void and the condition of the grout. Once the steel is surrounded by healthy grout again, the prestressing force gradually increases from zero to its maximum value over a certain length, known as the transmission length ( $L_T$ ). Therefore, the prestressing force along the structure can be schematically represented, as shown in Figure 3(a). For practical analysis and calculations, this can be simplified to the model shown

in Figure 3(b), which provides a more straightforward way of assessing the effect of tendon breakage on the structure.

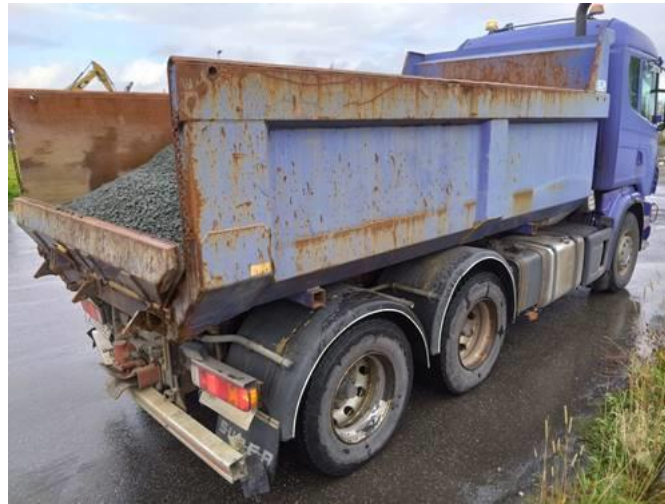
Figure 7: Day 1 calibration truck

The first calibration session was performed on 13<sup>th</sup> September 2023, using a 3-axle Scania R164GA6X4NA truck loaded with gravel, depicted in Figure 7. During this test, the truck traversed the bridge at predefined speeds of 10 km/h, 20 km/h, and 30 km/h. The driver was instructed to maintain a constant speed throughout each crossing. These controlled conditions were essential for accurately correlating the strain signal with the vehicle's Gross Vehicle Weight (GVW) during calibration.

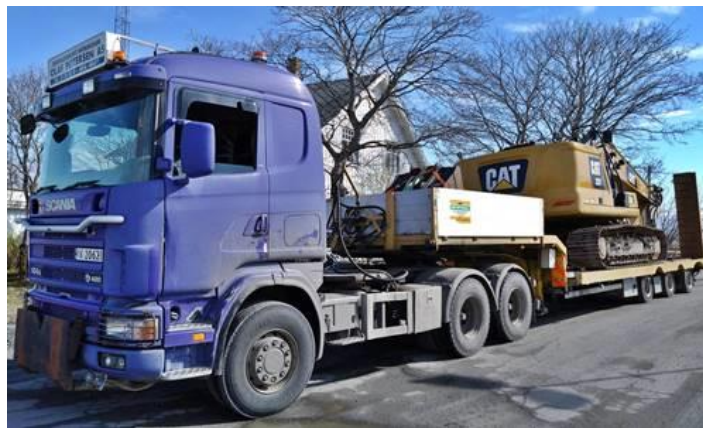
Figure 10: Day 2 calibration truck

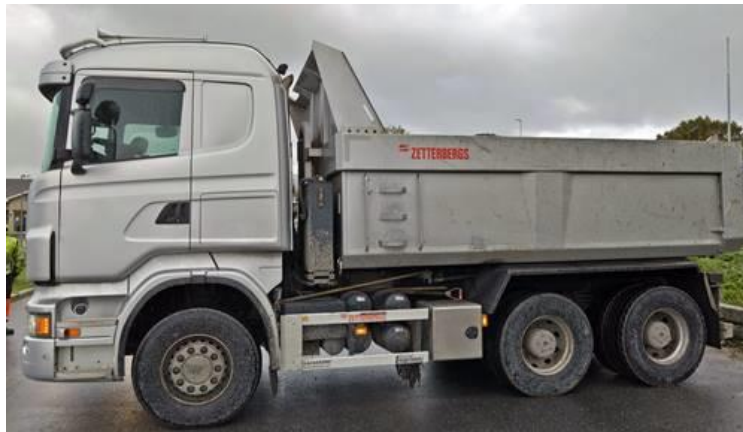
Figure 11: Day 3 calibration truck

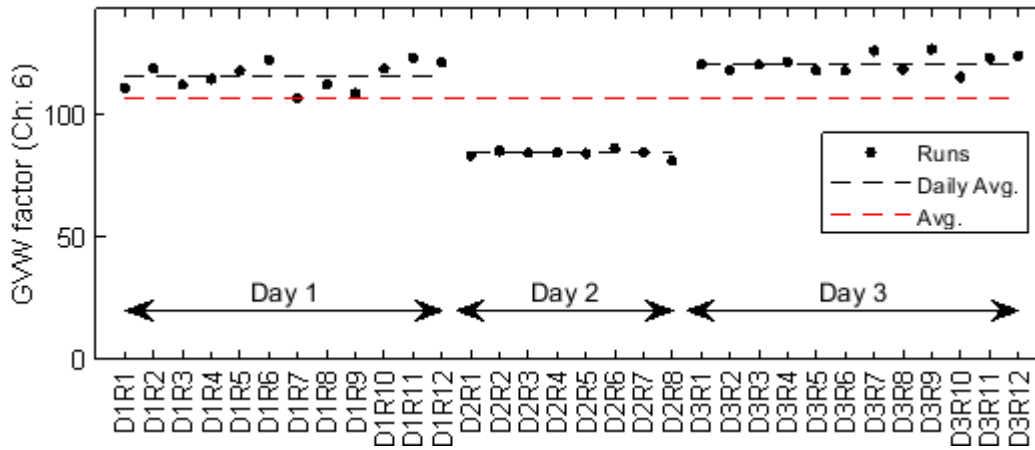
Figure 16: GWV factors for each calibration Day and Run

Results for a specific sensor (Channel 6) are shown in Figure 16, which presents the GVW factors for all calibration runs, grouped by calibration days. The sensor factor is computed for each calibration event, revealing some variation within events on the same day. These minor fluctuations in the factors are attributed to noise and dynamic effects. However, more significantly, the results indicate a distinct difference in the sensor factor between days, with notably smaller values observed on Day 2. This required further investigation to identify the underlying cause.

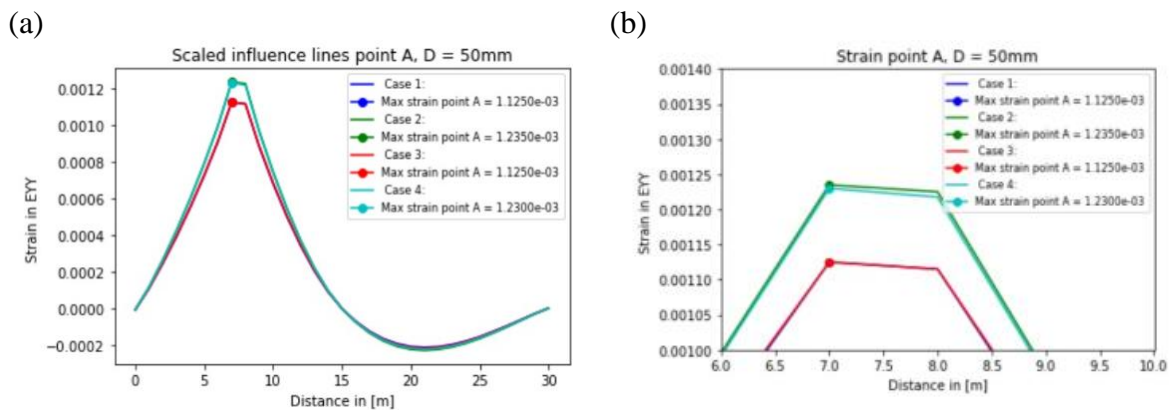
Figure 23: (a) Strain influence lines for different damage cases;  
 (b) Zoom in on the maximum values (Source: [14])

The variations in cross-sectional stiffness across the beam influence the magnitude of the influence lines, as shown in Figure 23. When the missing tendon is located on the opposite span of the measurement point (as seen in Case 3 compared to Case 1), there is no significant difference in strain. However, when the steel is absent on the same span as the measurement point (Cases 2 and 4), the change in strain becomes more pronounced. From this numerical example, it can be concluded that the strain responses under passing vehicles are indeed affected by damage to the post-tension system. The magnitude of the strain change will depend on both the location and extent of the damage.

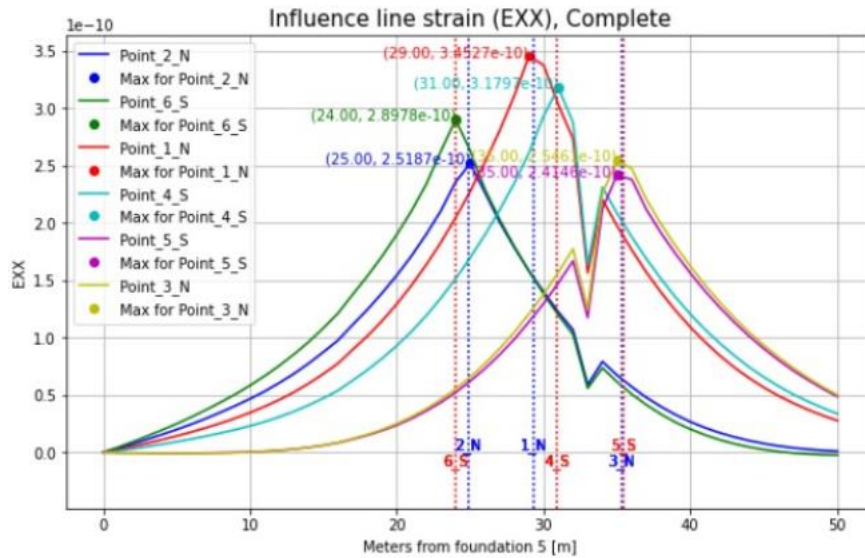
Figure 24: Influence lines for several sensor locations of the Herøysund Bridge. The results feature a sudden jump due to a numerical error that could not be fixed on time. (Source: [14])

Nevertheless, the study continued to investigate the effect of damage on the quasi-static component. The trends observed were similar to those for the static component, with larger variations seen in sensors located near the damage. However, the magnitude of the strain change was generally smaller in the quasi-static component compared to the static component.

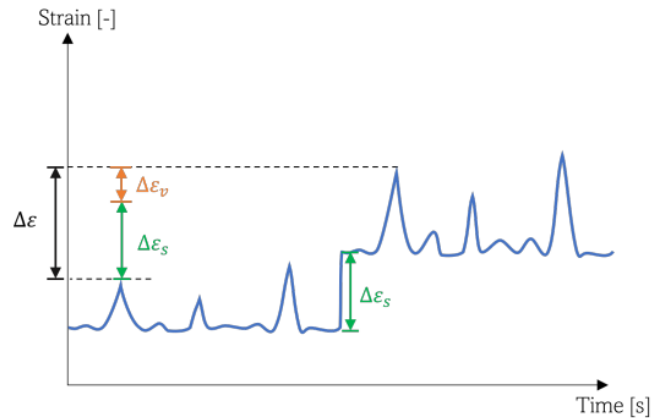
Figure 25: Strain values over time following a tendon breakage (Source: [16])

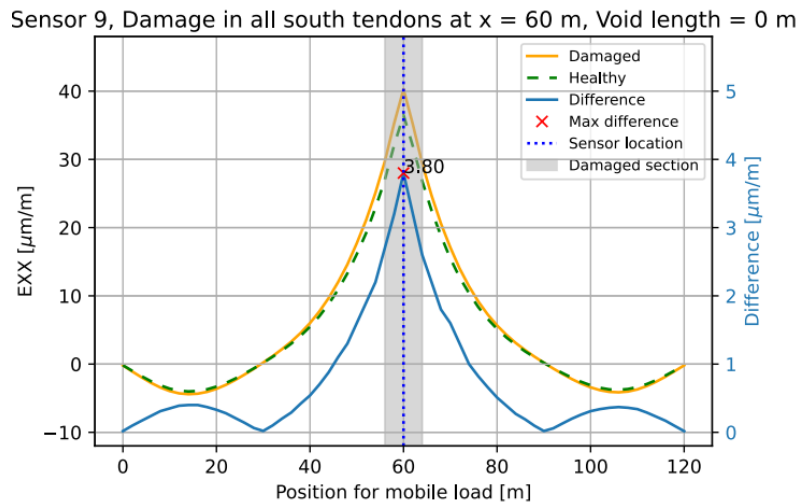
Figure 28: Strain influence lines and their difference for healthy and damage bridge (Source: [16])

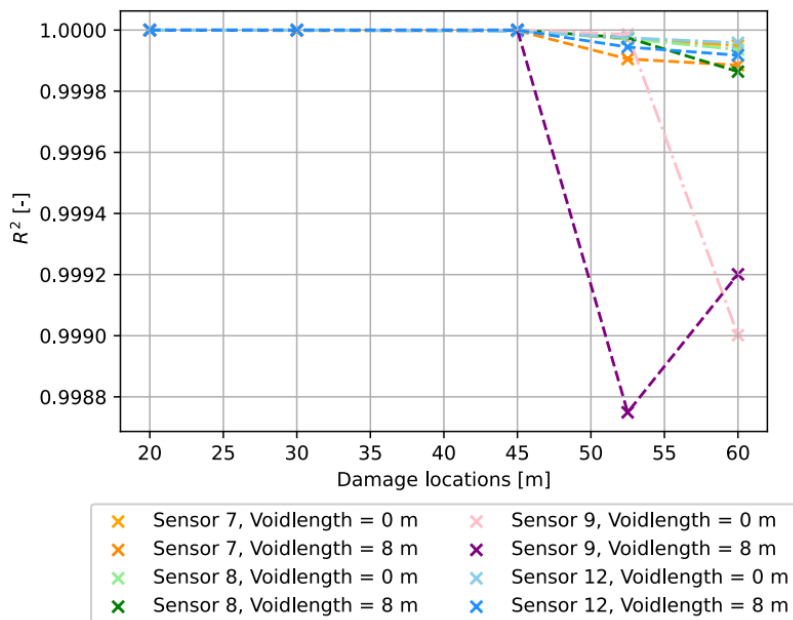
Figure 29:  $R^2$  values for various sensor locations, damage locations and void length. (Source: [16])

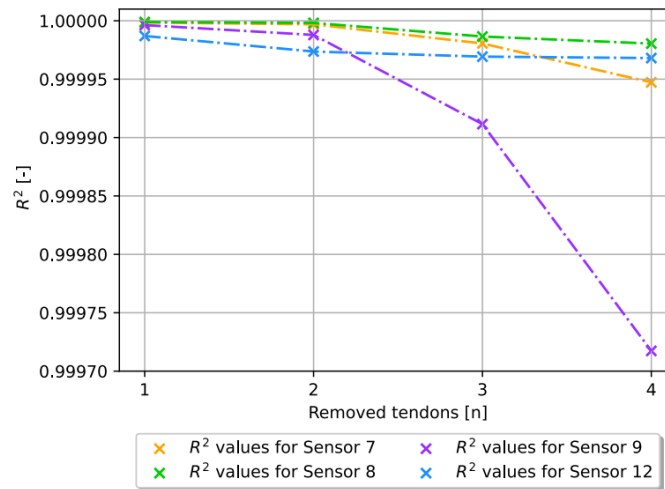
Figure 30:  $R^2$  values when removing entire tendons (Source: [16])

(Figure 30) for cases where more tendons are removed; however, these trends vary for each sensor. As expected, Sensor 9 (at mid-span) exhibits the greatest sensitivity to damage.

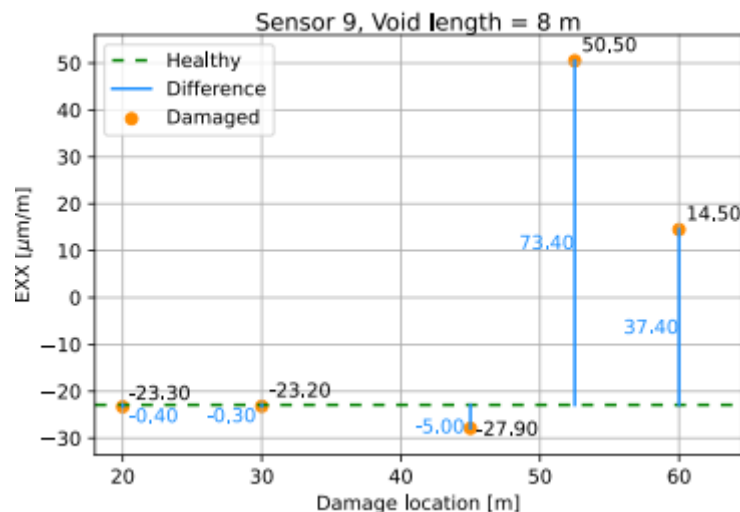
Figure 31: Static strain differences at Sensor 9 for a damaged tendon with 8 m void length at various damage locations (Source: [16])

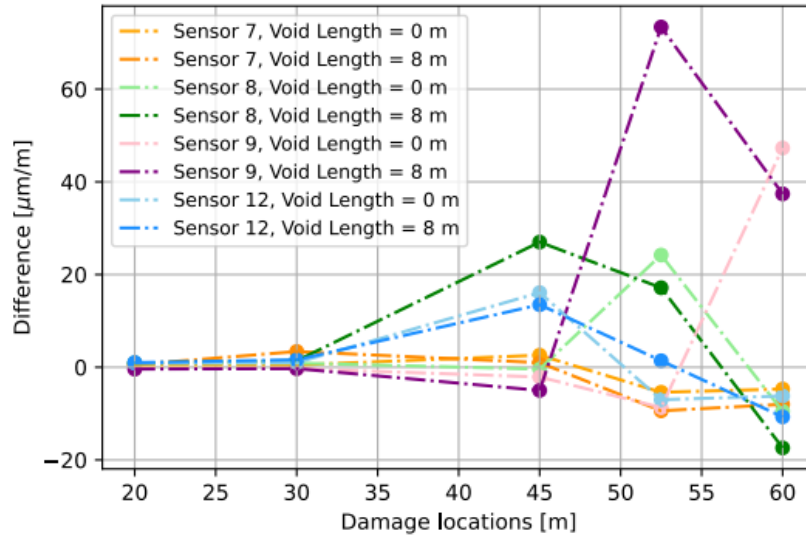
Figure 32: Static strain differences for all sensors and various damage scenarios (Source: [16])

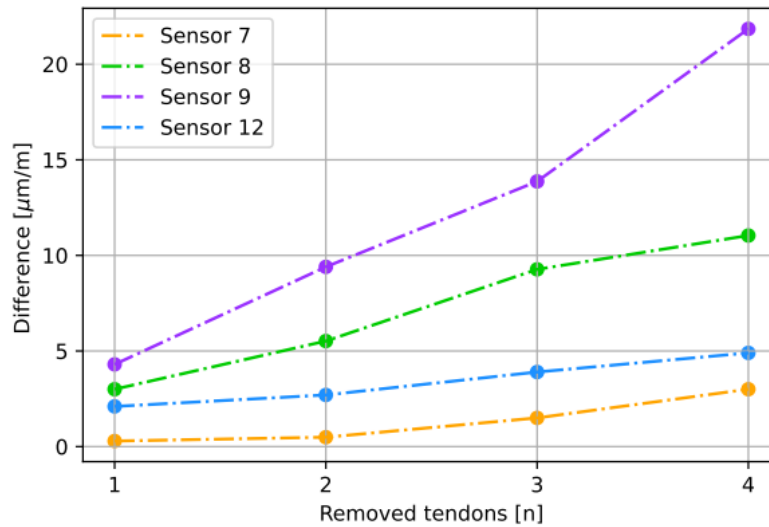
Figure 33: Static strain differences when removing entire tendons (Source: [16])

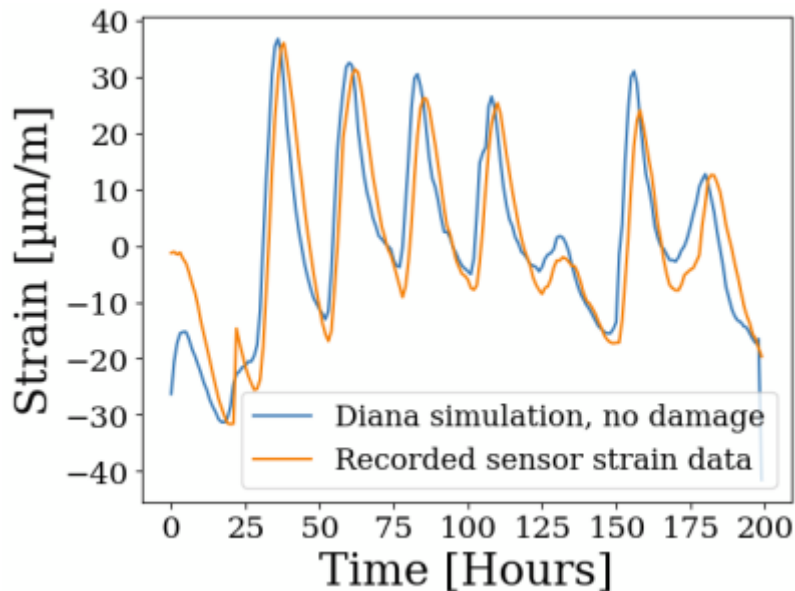
Figure 38: Comparison of simulated and recorded strain signals (Sensor Point\_1\_N) (Source: [17])
