# Summary of inspections and investigations on post-tensioning components of Herøysund Bridge, Norway (2017-2023)

Trondheim – January – 2024

WP2.A2

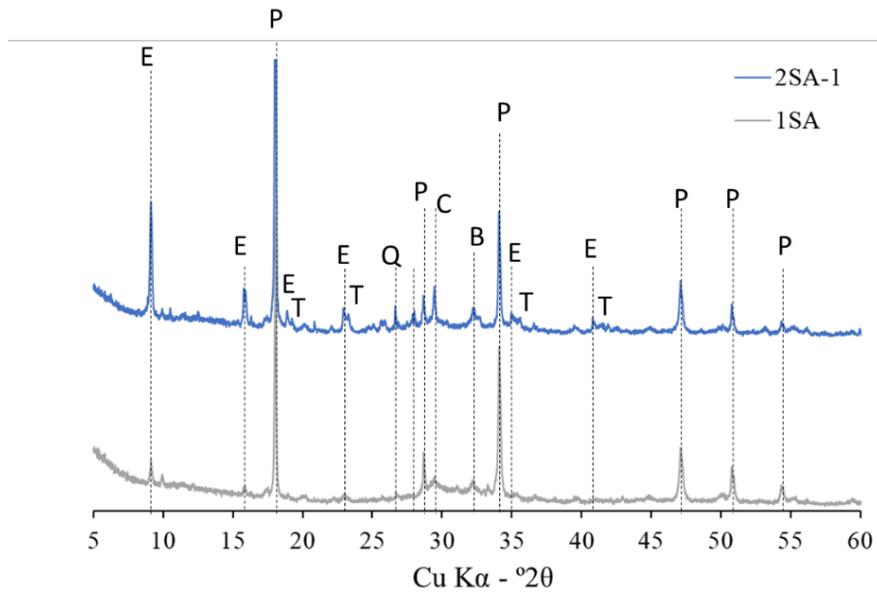
Figure A-13: Stacked diffractograms from Group 1 (1SA) and Group 2 (2SA-1) samples; E = Ettringite, T = Thaumassite, P = Portlandite, C = Calcite, B = Belite (cement clinker) [3].

The samples from Group 2 mostly exhibit similar phases as those of Group 1. However, there are some differences between the samples. Figure A-13 presents a direct comparison between sample 1SA (Group 1) and 2SA-1 (Group 2). It appears that there is more ettringite in Group 2. Additionally, there is more calcite in Group 2, which signifies a reaction with CO<sub>2</sub> from the air (assuming the same cement was used for both samples and therefore the initial calcite content should be the same). The ettringite peaks are not only of increased intensity but also show an asymmetric broadening at higher diffraction angles. From approximately 19 °2θ and upwards, the broadening becomes larger. As a result, there is an additional peak to the right of the ettringite. This could be a possible indication of thaumasite formation in the samples from Group 2.

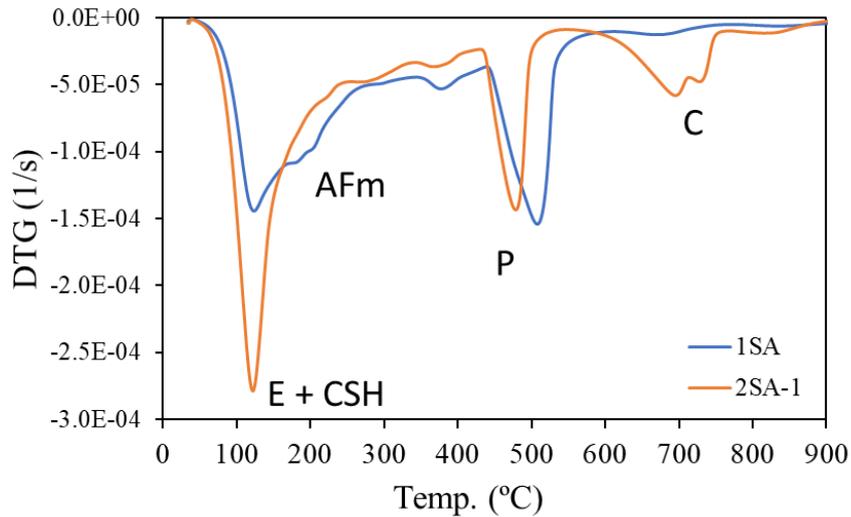
Figure A-14: TGA/DTG analysis of a sample from Group 1 (1SA) and Group 2 (2SA-1) [3].

The results confirm what was found with X-ray diffraction. Samples from Group 2 contain more ettringite (possibly also thaumasite) and more calcite. The width of the portlandite peak (P) indicates higher portlandite content in sample 1SA from Group 1. Calcite formation could be due to exposure to air (carbonation reaction: Portlandite (Ca(OH)<sub>2</sub>) + CO<sub>2</sub> → CaCO<sub>3</sub> + H<sub>2</sub>O), or possibly the addition of limestone filler if this was a separate batch. Ettringite formation (Aft) rather than calcium aluminum monosulfate (AFm) might be due to exposure to moisture and sulfate ions (dissolution and precipitation). As shown, water is also released from the carbonation reaction. To form thaumasite, access to sulfate (SO<sub>4</sub><sup>2-</sup>), carbonate (CO<sub>3</sub><sup>2-</sup>), silicate from C-S-H, and moisture is necessary. Thaumasite formation occurs at temperatures <15°C but is also observed at room temperature (20°C) once it's

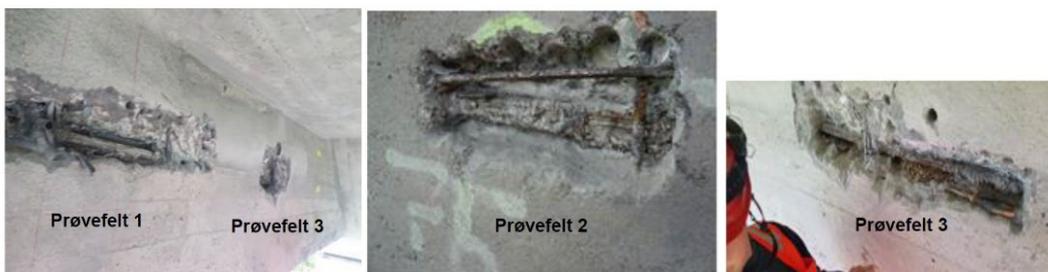
Figure D-1: Inspected test locations [1].

Inspection and sampling were carried out at three predetermined test locations that were previously examined and documented in the Dekra report [6]. Figure 2-1 illustrates the location of Test locations 1, 2, and 3 and Figure D-1 provides a closer look of the locations after concrete removal. Test locations 1 and 3 are 1 m distance apart and are located on the west side of the bridge. Original drawings of tendon placement in the main bridge spans of Herøysund Bridge are shown in Appendix 1 of the report [1]. All the test locations are located on Tendon 2 (Cableway 2N, 2S), but not on the same duct.

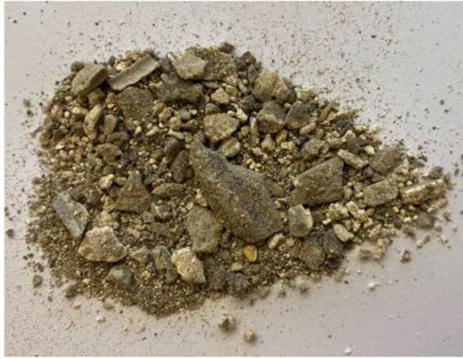
Figure D- 4: Filler material from Test location 1 [1].

The inspection also reveals the presence of voids in the duct (1-6, 1-7, 1-8 (Vedlegg 5), 1-9, 1-11). From the inspection report carried out by Lise Bathen voids were found to be dry (1-8) (Vedlegg 5) [1]. The consistency of the filler material was found to vary within the inspected area, ranging from normal dry to frost-damaged/non-frost-damaged material. Figure D-4 shows an image of filler material from Test location 1.

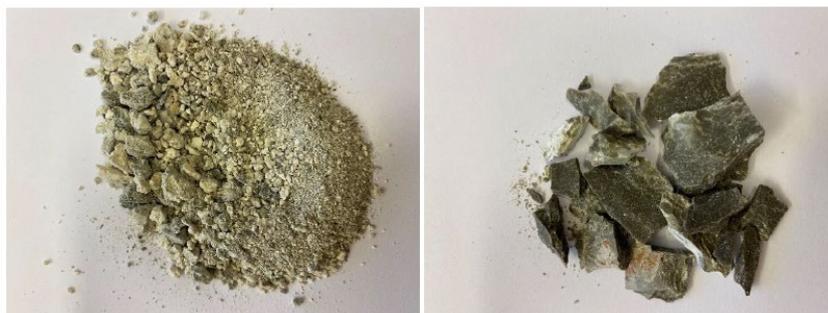
Figure D-7: Filler material from two locations at Test location 2 [1].

From the inspection of filler material, it was found that some parts were filled with filler material, but some parts included voids (2-2). The wires covered with filler material showcased full protection from corrosion whereas parts exposed to voids were susceptible to corrosion (2-5). Figure D-7 shows filler material from two areas in Test location 2.

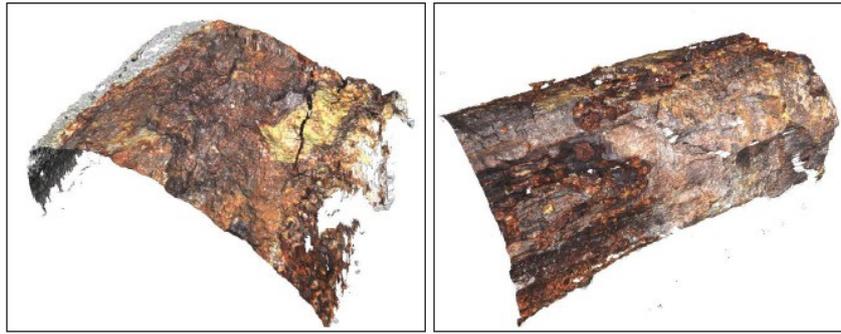
Figure D-13: 3D models of two different areas on a tension wire [1].

- On one of the 90 mm long segments, there were deep corrosion pits over a length of 50 mm. The pits had an elliptical shape with a length of 5-15 mm, a depth of up to 1.5 mm, and a width of 3-4 mm. All the pits were on the same part of the circumference, while the rest of the circumference showed no signs of corrosion.
- On another 70 mm long segment, uneven and uniform corrosion was observed on one-half of the circumference, with a diameter in the range of 5.9 – 6.1 mm along the entire length of the sample. While no corrosion was observed on the remaining part of the circumference.

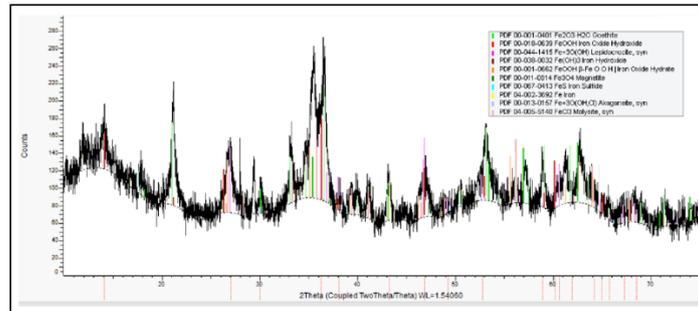
Figure D-14: XRD analysis of corrosion products from corroded wire [1].

Initially, X-ray diffraction (XRD) analysis of the corrosion products was planned to be performed directly on the sample pieces, but considering the suitability of the analysis, it was performed on the scraped corrosion products from the samples. First, the samples were powdered, mounted in a special holder, and then placed into the machine. Figure D-14 displays the result of the XRD analysis in the form of a 'Diffractiongram.' Numerous possible chemical elements/compounds can be witnessed, although some of the peaks are likely due to noise. It is, however, crucial to note that iron compounds with sulfur (sulfide) and chloride are documented, in addition to several Fe-O compounds.

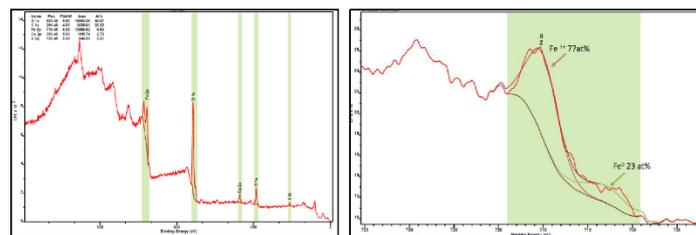
Figure D-15: XPS analysis of corroded wire from Test location 3 [1].

X-ray photoelectron spectroscopy (XPS) analysis was also conducted to analyze the surface chemistry on the corroded tension wire. The results, as shown in Figure D-15, indicate that the surface consisted of O, C, Fe, Ca, and S. A significant amount of trivalent iron ( $\text{Fe}^{3+}$ ) was also detected, as shown in the right figure. This likely originates from  $\text{FeOOH}$  and/or  $\text{Fe}(\text{OH})_3$  compounds. A small amount of sulfur (2.37 at. %) was also detected, while no chloride was found.

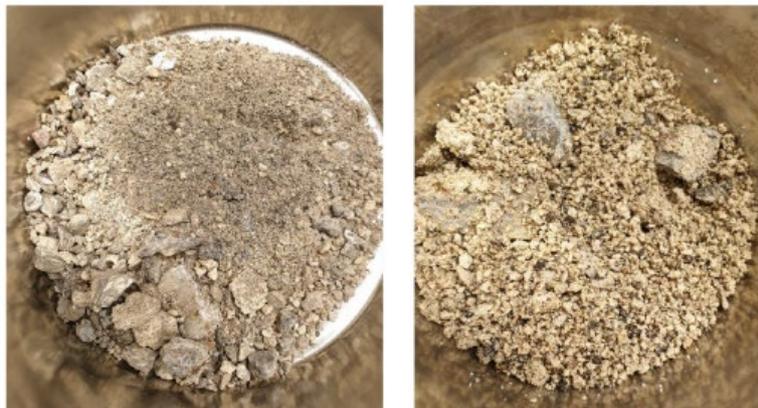
Figure D-16: 'Dry' (left) and 'moist' (right) filler material [4].

The filler material from Test location 1 (referred to as the 'dry sample') and from Test location 3 (referred to as the 'moist sample') as shown in Figure D-16 was analyzed by SINTEF. Detailed results are described in [4].
